DYNAMIC TESTS OF THE MODIFIED CALIFORNIA TYPE 20 BRIDGE BARRIER RAIL

SERIES XXVIII

RESEARCH REPORT

CA-HY-MR-6589-1-72-30

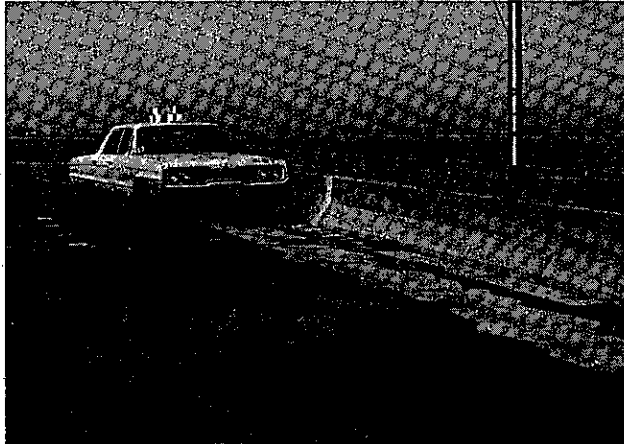
The California Type 20 Bridge Barrier Rail, designed by the California Division of Highways Bridge Department, was proven effective in a test series conducted in 1969[1]. That barrier is shown in Figure 1.

FIGURE 1 - CALIFORNIA TYPE 20 BRIDGE BARRIER RAIL - TEST BARRIER

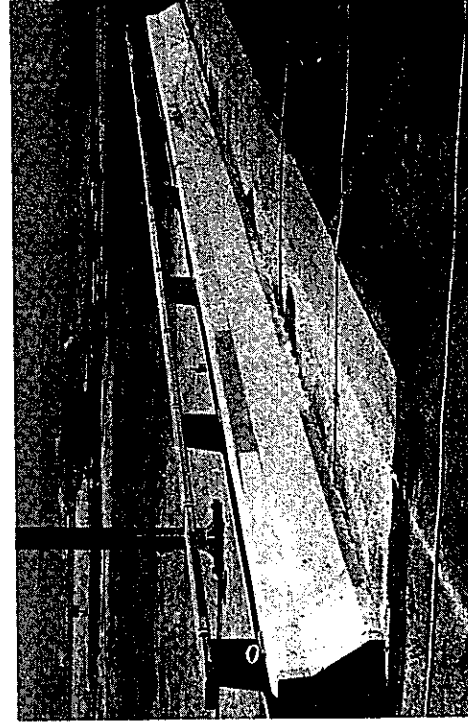
FIGURE 5

The vehicle in each of the four tests was effectively retained and redirected without any significant damage to the bridge rail (Figure 5).

COMPARISON OF BARRIER DAMAGE FOR TESTS 281-284

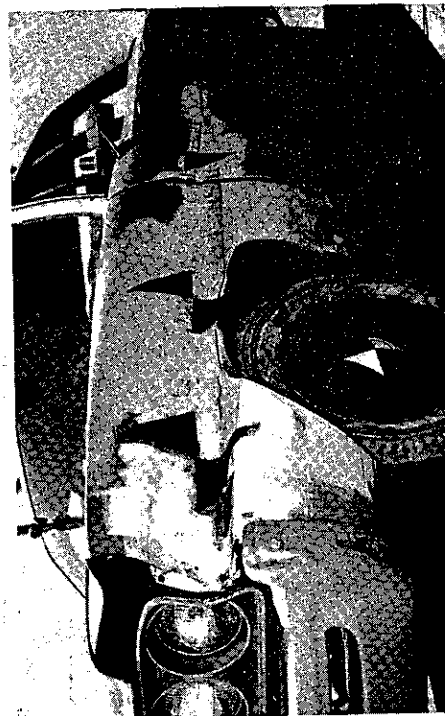
FIGURE 6

Vehicular damage, which was considered minor, increased only slightly relative to the increase in impact velocity (Figure 6). The same test vehicle was reused for all four 5° tests with only cosmetic sheet metal and paint repairs required between tests and for a subsequent larger angle test.

Vehicle sheet metal contact with the barrier was at the left front fender where the steel railing creased the sheet metal to a depth of 0.2 ft. There was also minor sheet metal deformation and paint abrasion along the left side and at the left rear fender. There was no apparent damage to the vehicle suspension or steering system from the four impacts.

COMPARISON OF VEHICULAR DAMAGE FOR TESTS 281-284

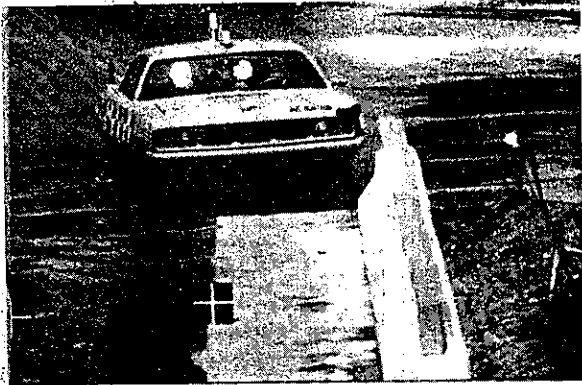
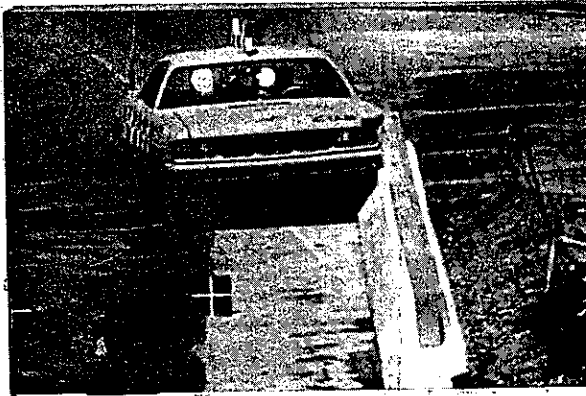
TEST NO. 283
 DATE 7/21/71
 VEHICLE 1969 Dodge Sedan
 SPEED 57 mph
 IMPACT ANGLE 5°
 VEHICLE WEIGHT 4895 Lbs.
 (Incl./dummies & instrumentation)
 DUMMY RESTRAINT Lap Bel

BARRIER TESTED Modified Type 20 Bridge Rail
 LENGTH OF INSTALLATION 65' ±
 PASSENGER COMPARTMENT DECEL. Long. 1.5 Lat. 2.6
 (Highest 50ms average)
 MAXIMUM VEHICLE RISE 0.6'
 EXIT ANGLE 1°
 BARRIER DAMAGE Negligible

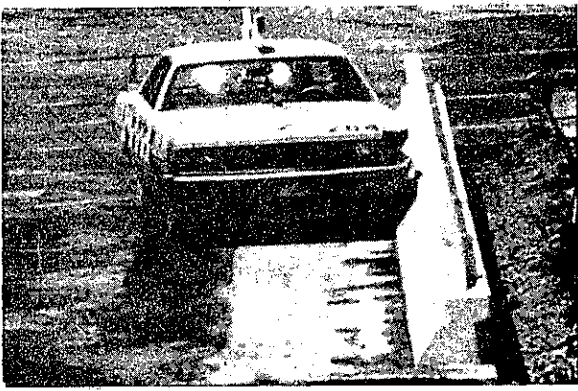
BARRIER TESTED.....	Modified Type 20 Bridge Rail	TEST NO.	284
LENGTH OF INSTALLATION.....	65' ±	DATE	7/21/71
PASSENGER COMPARTMENT DECEL. (Highest 50ms average)	Long. 1.6 Lat. 3.5	VEHICLE.....	1969 Dodge Sedan
MAXIMUM VEHICLE RISE.....	0.6'	SPEED.....	62 mph
EXIT ANGLE.....	1°	IMPACT ANGLE.....	5°
BARRIER DAMAGE.....	Negligible	VEHICLE WEIGHT.....	4895 Lbs (Incl./dummies & instrumentation)
		DUMMY RESTRAINT.....	Lap Belt

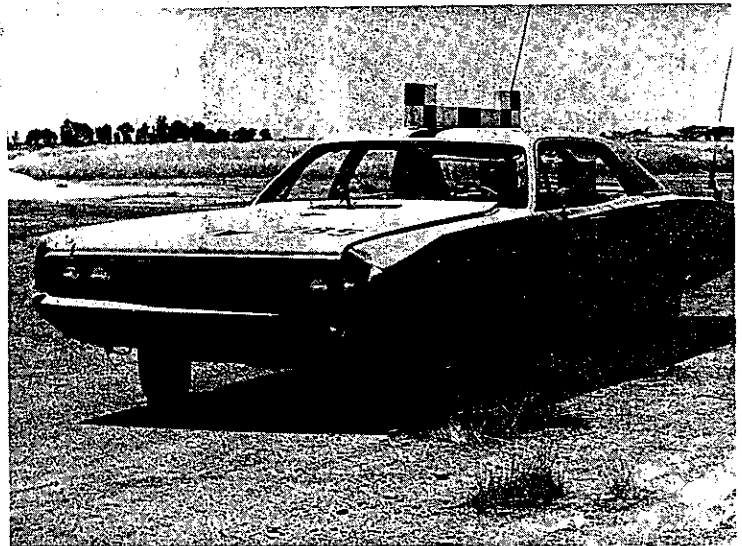
FIGURE 12 - VEHICLE DAMAGE
TEST 285

Vehicle sheet metal contact with the barrier was at the left front fender where the steel railing creased the sheet metal to a depth of 0.45 ft. The left end of the front bumper and the left frame horn were also deformed. There was minor sheet metal deformation and paint scrapes along the entire left side of the vehicle to the rear fender which was creased to a depth of 0.14 ft. The rear fender deformation was indicative of a more severe rear-end slap than had occurred in any of the first four 5° tests. There was no apparent damage to the suspension or steering systems and the vehicle was still operable.

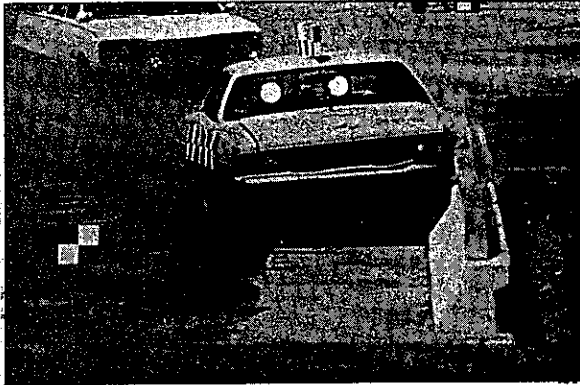
I + 0.13 Sec.

BARRIER TESTED Modified Type 20 Bridge Rail
 LENGTH OF INSTALLATION 65' ±
 PASSENGER COMPARTMENT DECEL. Long. *
 (Highest 50 ms average) Lat. *
 MAXIMUM VEHICLE RISE 0.7'
 EXIT ANGLE 2°
 BARRIER DAMAGE Negligible
 * ERRONEOUS DATA

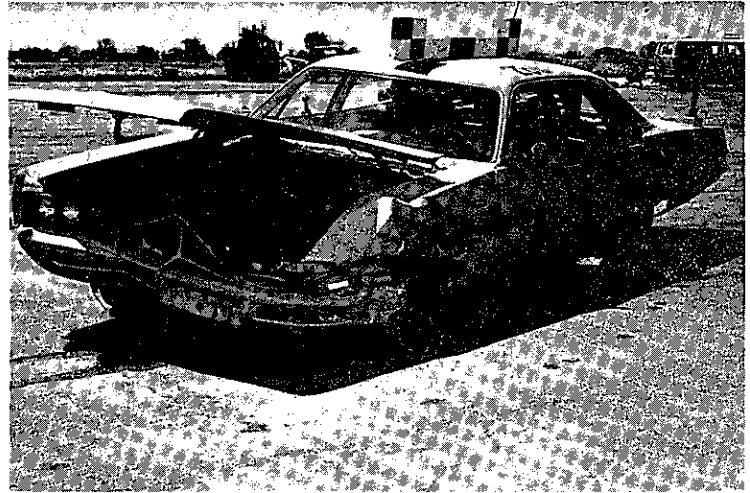
The bridge rail effectively retained and redirected the vehicle without sustaining any damage (Figure 14). Vehicle damage was relatively severe (Figure 15).

FIGURE 15 - VEHICLE DAMAGE
TEST 286

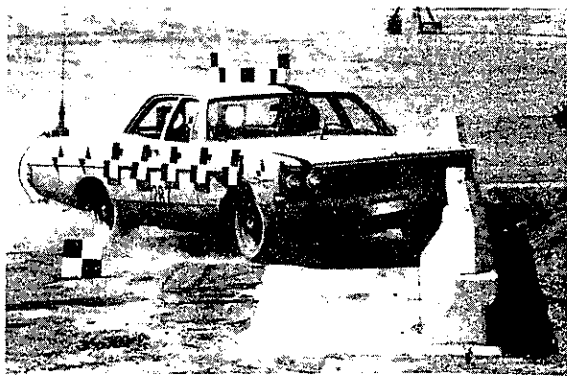
Gadd Severity Index	575
Max. Seat Belt Transducer Load (lbs.)	650

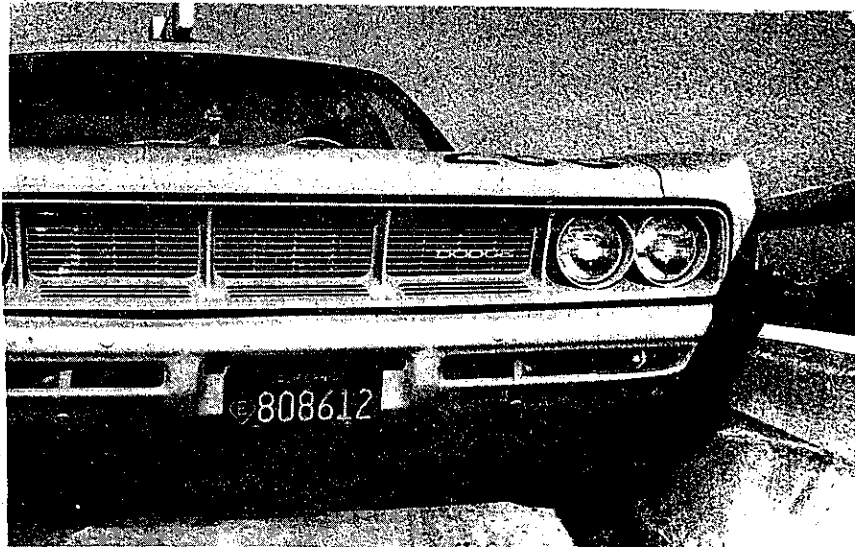
This increased damage, consisting essentially of sheet metal deformation, was attributed primarily to the 7 inch lower parapet/railing of the modified design. (Figure 22, Modified Type 20 design - Figure 23, standard Type 20 design).

FIGURE 22 - VEHICLE NEXT TO
MODIFIED TYPE 20 BARRIER

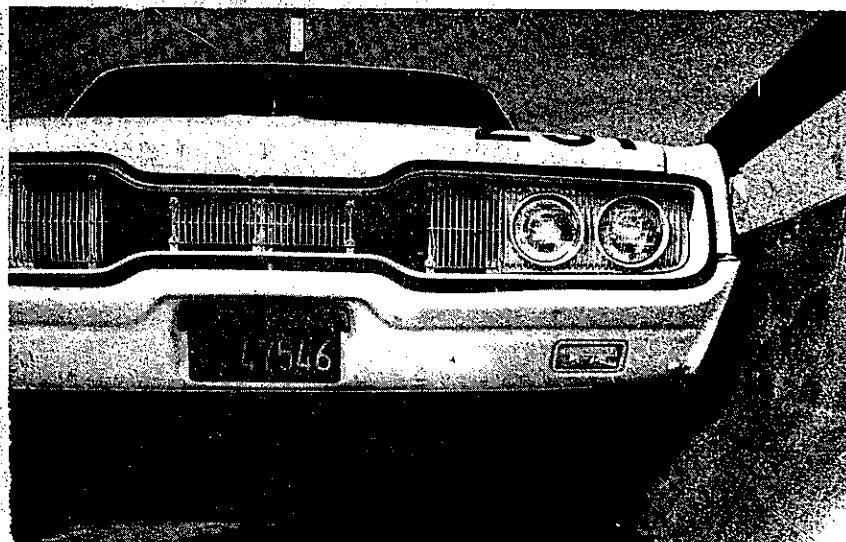
FIGURE 23 - VEHICLE NEXT TO
STANDARD TYPE 20 BARRIER

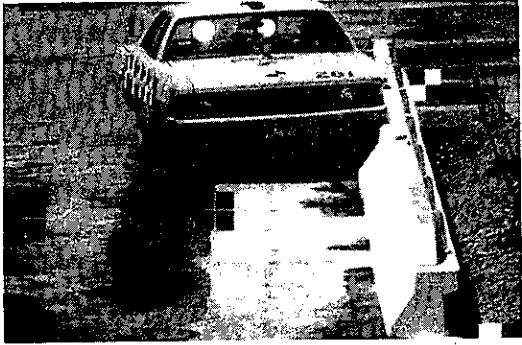
FIGURE 24 - VEHICULAR IMPACT
INTO MODIFIED TYPE 20 BARRIER
TEST 281

Analysis of the high speed data film from Tests 281 - 284 revealed that upon impact the test vehicle front bumper thrust over the top of the concrete parapet of the Modified Type 20 design. This permitted fender/railing contact prior to the initiation of vehicular redirection (Figure 24) whereas with the Standard Type 20 design the bumper contacted the concrete parapet and assisted in vehicular redirection (Figure 25).

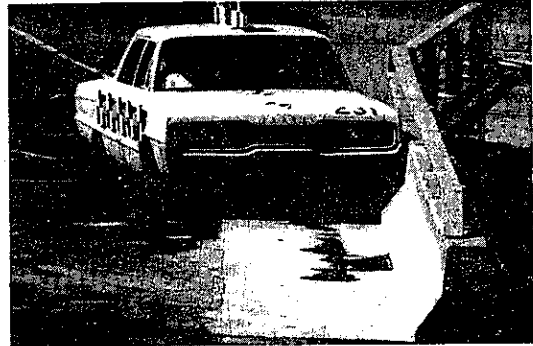
FIGURE 25 - VEHICULAR IMPACT
INTO STANDARD TYPE 20 BARRIER
TEST 231

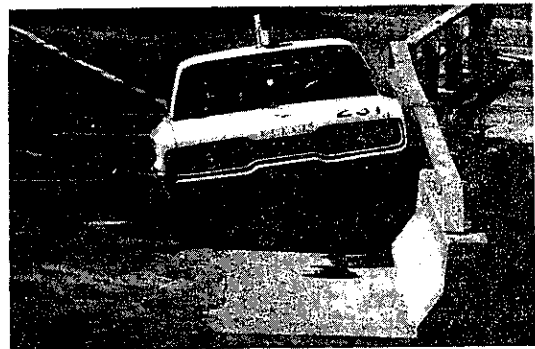
The 0.6 ft. average vehicle rise for the four low angle tests on the Modified Type 20 design was considerably less than the 1.3 ft. rise observed in the similar low angle tests on the Standard Type 20 design (Figures 26 and 27).

FIGURE 27 - VEHICULAR RISE
ON STANDARD TYPE 20 BARRIER
TEST 231
